RAVEN SERVICES CORPORATION 2200 SIXTH AVENUE, SUITE 519 SEATTLE, WASHINGTON 98121 (206) 443-1126; FAX (206) 443-1128

CONFIGURATION, SAMPLE LOCATIONS AND PCB CONCENTRATION IN THE SOIL PILE

In November, 1989, Raven Services Corporation acquired samples from a pile of excavated soil south of the Georgetown Steam Plant that resulted from the removal of several tanks. These tanks were three residuum fuel tanks that, in the past, stored Bunker C oil to fire the plant boilers. Also removed was a smaller heating oil tank.

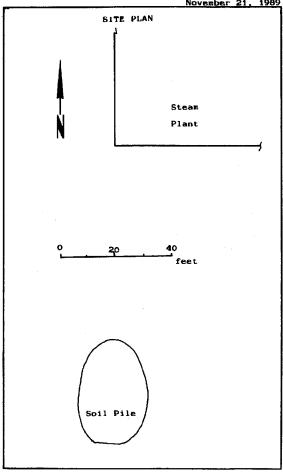
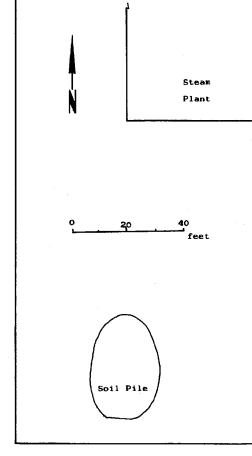
No PCBs were detected in any of the soil pile samples. Total petroleum hydrocarbons, however, ranged from 63,800 ppm to 8.6 ppm. The distribution of these hydrocarbons appears correlated with the presence of the oily crust on the surface samples. The deeper samples were fill sand, and contained 555 and 1027 ppm respectively. The hydrocarbon distribution is not uniform throughout the pile.

at 6 feet \$P-3 ND Contours drawn freehand Legend: Contour interval = 1 foot Soil sample Sample number PCB ppm

The volume of the excavated soils was estimated as follows:

Contour Section	<u>Area</u>
0'	896
1'	776
2'	650
3,	535
4 '	419
5,	323
6'	231
top[s]	12
•	3832 cu ft

$$\frac{3832 \text{ cu ft}}{27 \text{ cu ft/cu yd}} = 142 \text{ cubic yards}$$

This estimate is probably high for two reasons: 1) the pile is drawn less oval-shaped than it actually is, and 2) the slope between each contour has not been taken into account.
